**FERMILAB MU2E PS AND DS MAGNET PROGRAM
PROJECT 39532**

NUMBER: 39532M00005

SUBJECT: DS8 Winding Incident on June 28, 2019

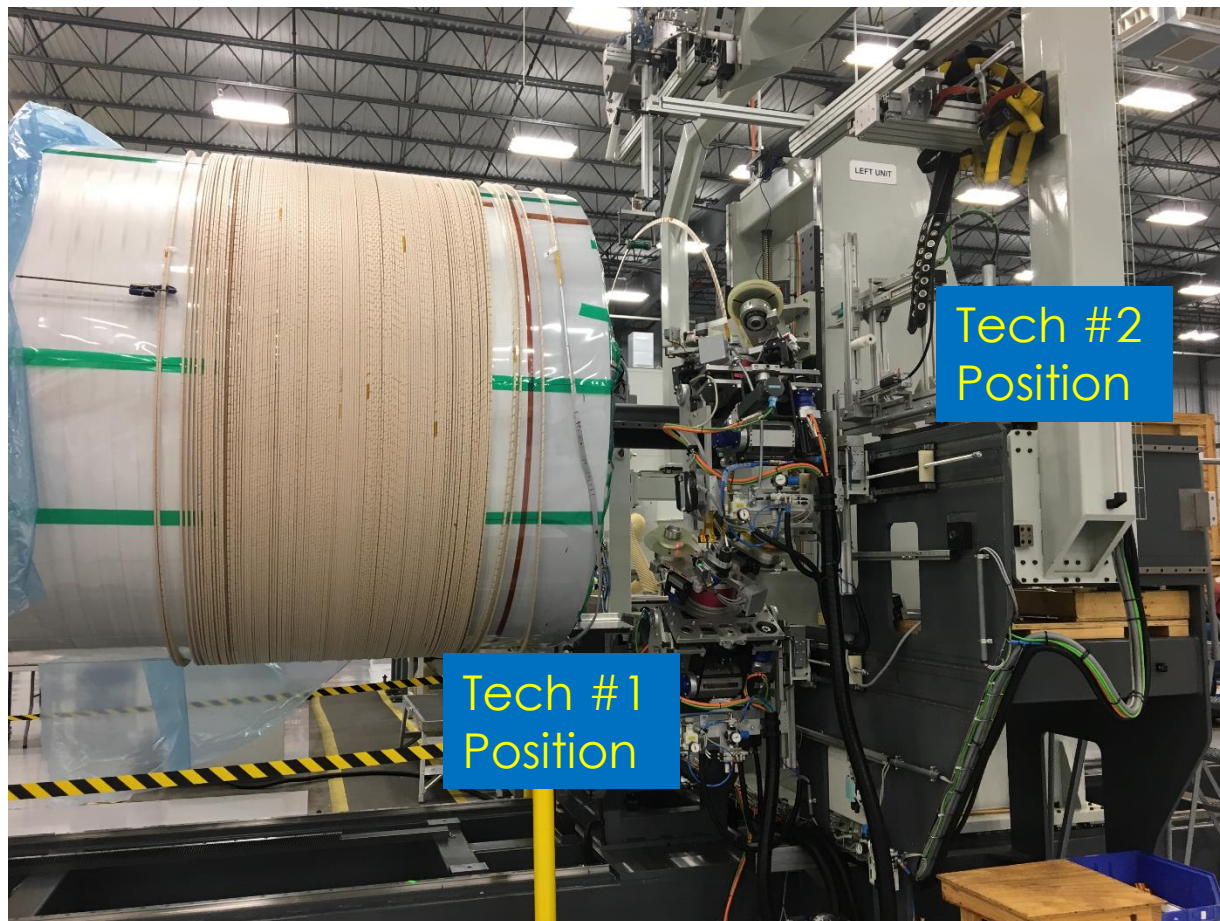
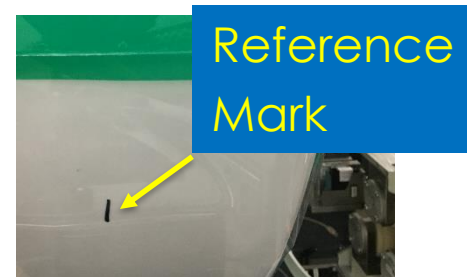
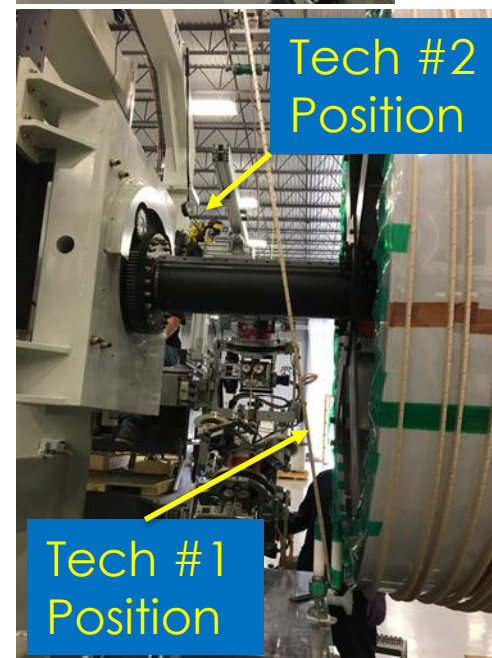
Standard Process , Photos

- **Technician #1 stands next to the wrapping heads to ensure that the conductor transitions smoothly onto the mandrel at the transition point. Technician has to manually migrate conductor horizontally to ensure that it is approximately 4-6 inches from the end of the mandrel as indicated by a reference mark on the mandrel O.D.**
- **Technician #2 stands up on the elevated platform and controls the mandrel speed with the “dancer”.**
- **Techs are instructed to stop (or call for the operator stop) the machine for any adjustments or if anomalies are observed.**

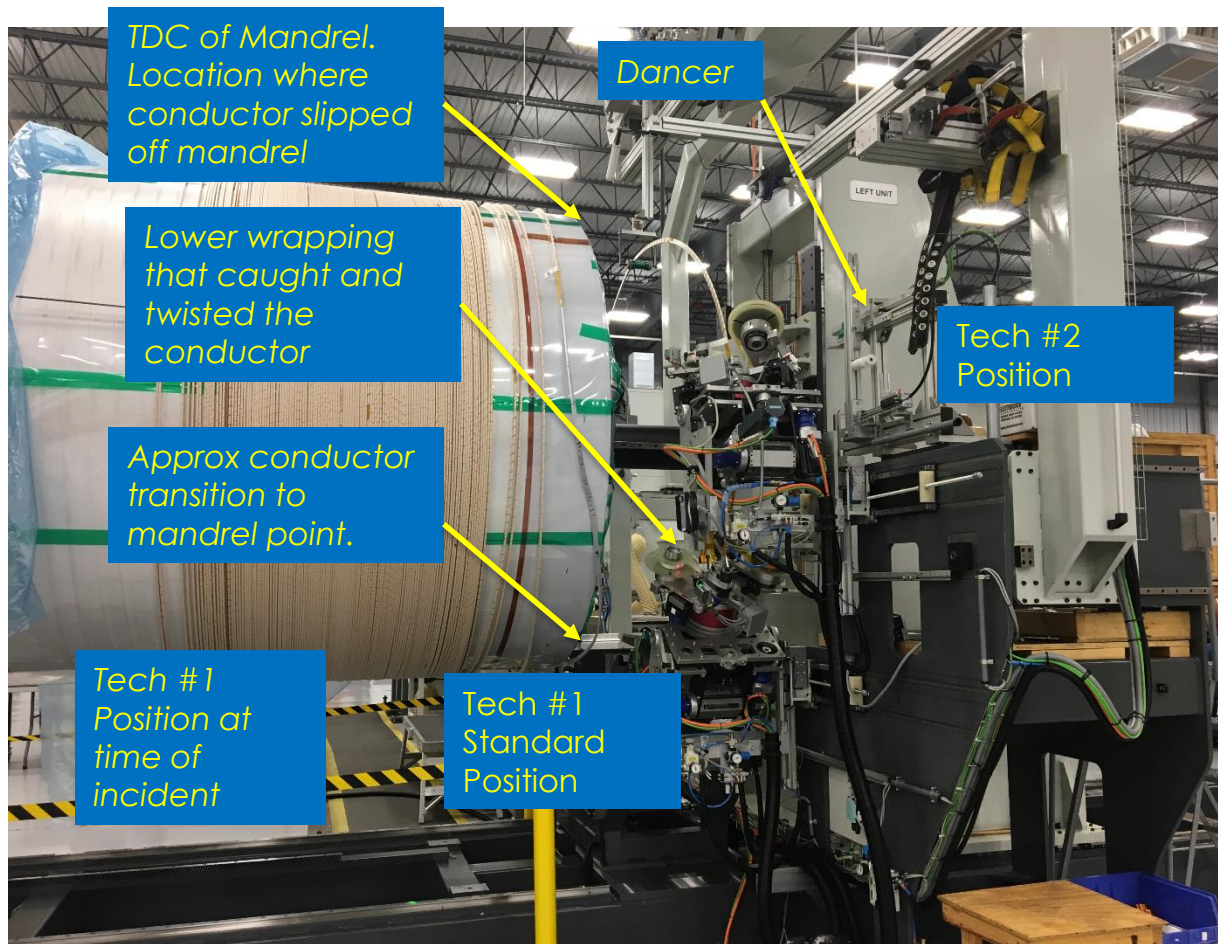
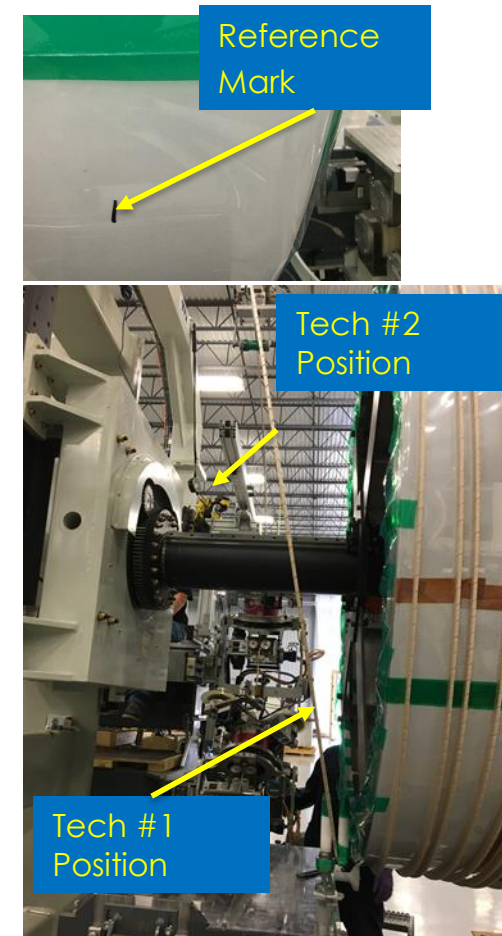
DS8 Winding Incident Description, Photos

- Technician #1 had briefly stepped 4 to 5 feet to the left of his normal position and was adjusting the conductor on the opposite end of the coil while the winder was still running.
- During this time, his attention was not on maintaining the 4-6 inch position of the conductor from the end of the mandrel.
- At the same time Tech #2 observed that the conductor had slipped off the end of the mandrel at TDC well past the transition point, causing it to become unstable.
- Tech #2 immediately called for the operator to stop the machine.
- The operator stopped the machine, but as the lower wrapping head was coasting to a stop it caught the unstable conductor and twisted it.
- The winding process was stopped immediately.

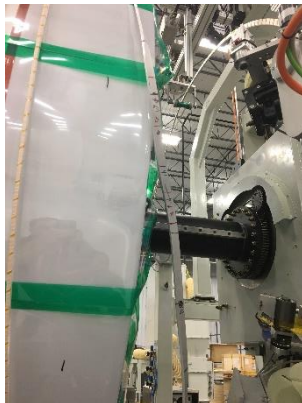
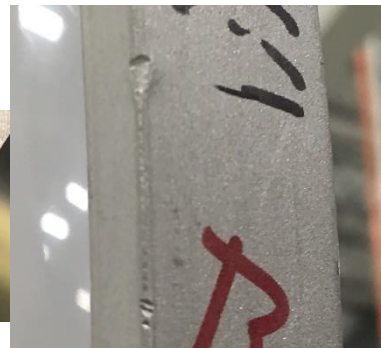
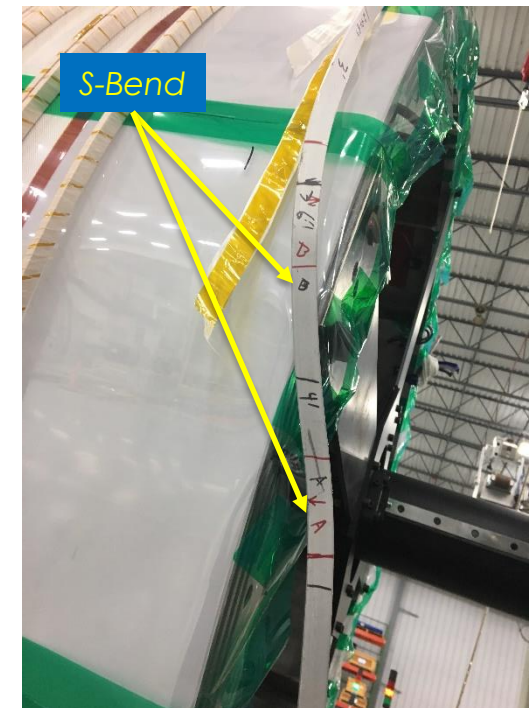
- **No one was injured from this incident.**
- **Twisted/bent Conductor**
 - Conductor was twisted 77 deg along a 9 ft section of conductor
 - 61% of the twist was on a 38 inch section.
 - S-Bend
 - There was also an “S-bend” that spanned 14 inches.
 - Radius of bends R18.3” and R14.0”.
 - Measured by laser tracker.
- **Minor burrs**
 - No greater than 0.5 mm deep.
- **QN#: 7054611 was created to document this incident**
