(8) PART NAME: ZBOM		(9) PART/DWG NO.: 39532-D-3100			(10) REV: B
(11) CLASSIFICATION: (PRIORITY) Major	(12) LOCATION: EMS Tupelo	(13) HWCI NO. AND NAME: 39532-D-3105-2 - THERMAL BRIDGES, OD, PS2

(31) REQUIREMENTS: (DESCRIPTION) Thermal bridges to be continuous (PS2) 08/18/2020 16:16:04 PST SHARON DAVENPORT (DAVESH) Each thermal bridge to be a single continuous piece per Mu2e-doc-3647 (Reference Design of the Mu2e Production Solenoid.) 10/16/2020 08:25:18 PST (DAVESH) This text replaces the previous text: Each Outer diameter thermal bridge (39532-D-3105-2) must be produced as a single continuous piece of the length sufficient to make the connection with the cooling tubes per Mu2e-doc-3647 (Reference Design of the Mu2e Production Solenoid.)

(32) NONCONFORMING CONDITION: (TEXT) Item No: 0001 Found At: EMS Tupelo Defect Code: HDDM INS - Hardware Damaged Damaged outer thermal bridge(s) 10/16/2020 08:26:16 PST (DAVESH) During lead excavation on the PS2 Coil (39532-D-3122) per Mu2e Manufacturing Work Instruction 39532P00060, operation 320, a technician damaged the aluminum thermal bridges. Twenty-three outer thermal bridges were scratched and dented near their bases during removal of a

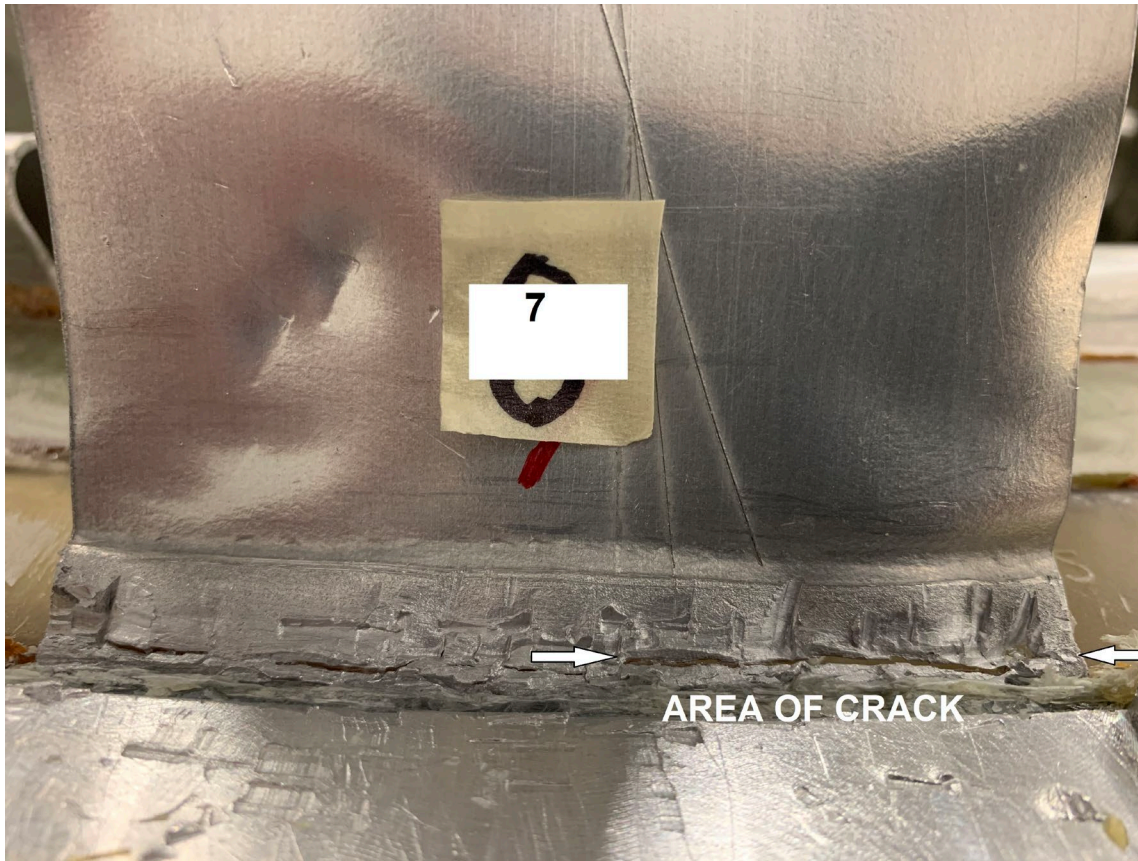
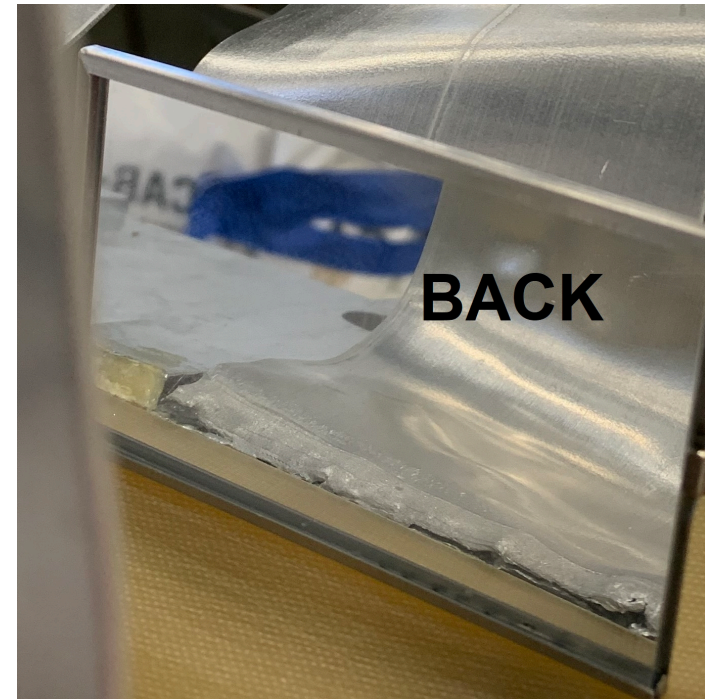
Picture of Thermal Bridge 7

- Use the thermal bridges as per the following instructions except for the cracked thermal bridge (labeled #7) which is to be removed.
- Special instructions for PS2 Outer Thermal Bridges:
 1. Bend the outer thermal bridges (except #7) into place per Operation 350 of 39532P00060 Rev. A (PS2 Coil and Shell Assembly Work Instructions). While gripping the free end of the thermal bridge start to bend it over 90° and using a plastic head mallet, gently tap the thermal bridges to its final horizontal position.
 2. If *any* thermal bridge cracks or breaks, Stop work and immediately notify Engineering for further direction.
 3. Remove the cracked thermal bridge (labeled #7) at Operation 350 and gently file down any sharp edges ensuring cleanliness is maintained.

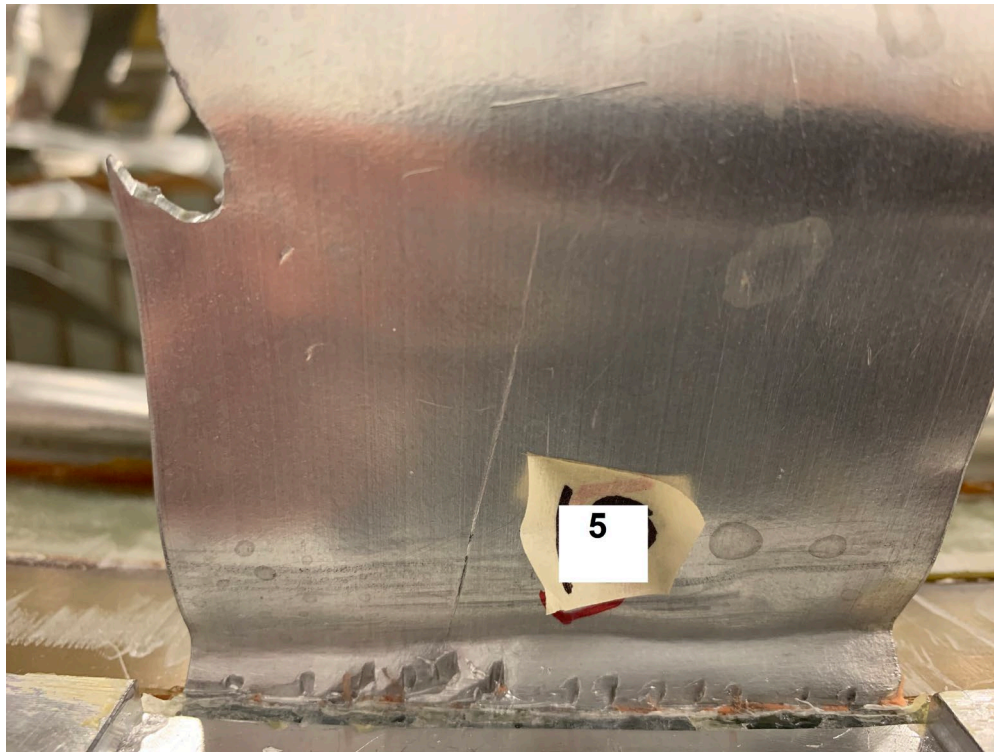
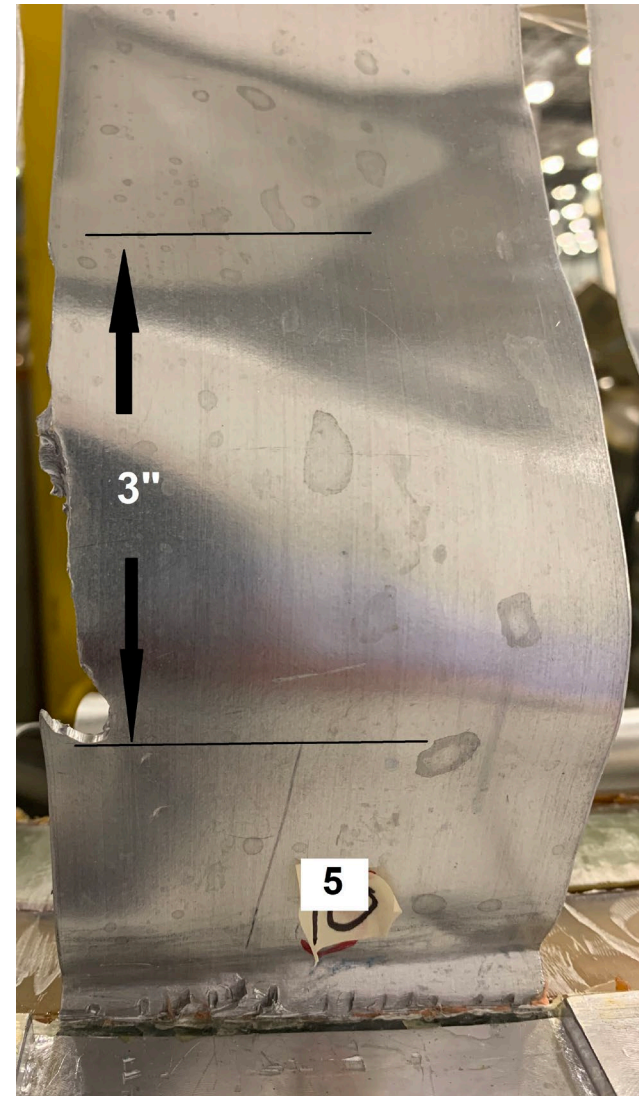
Pictures of Thermal Bridge 5

TB# 5 does have a small surface crack on the O.D. of the bend. It still feels "secure" not loose. Also, after reviewing the before pics it appears that this is not a new crack and was present before being formed into the slot.

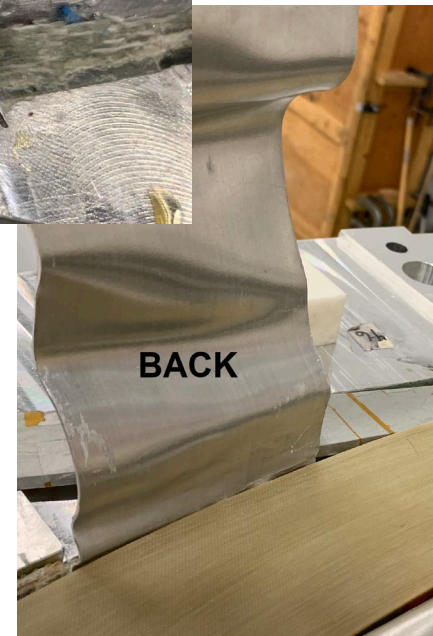
Small tear on left side at base

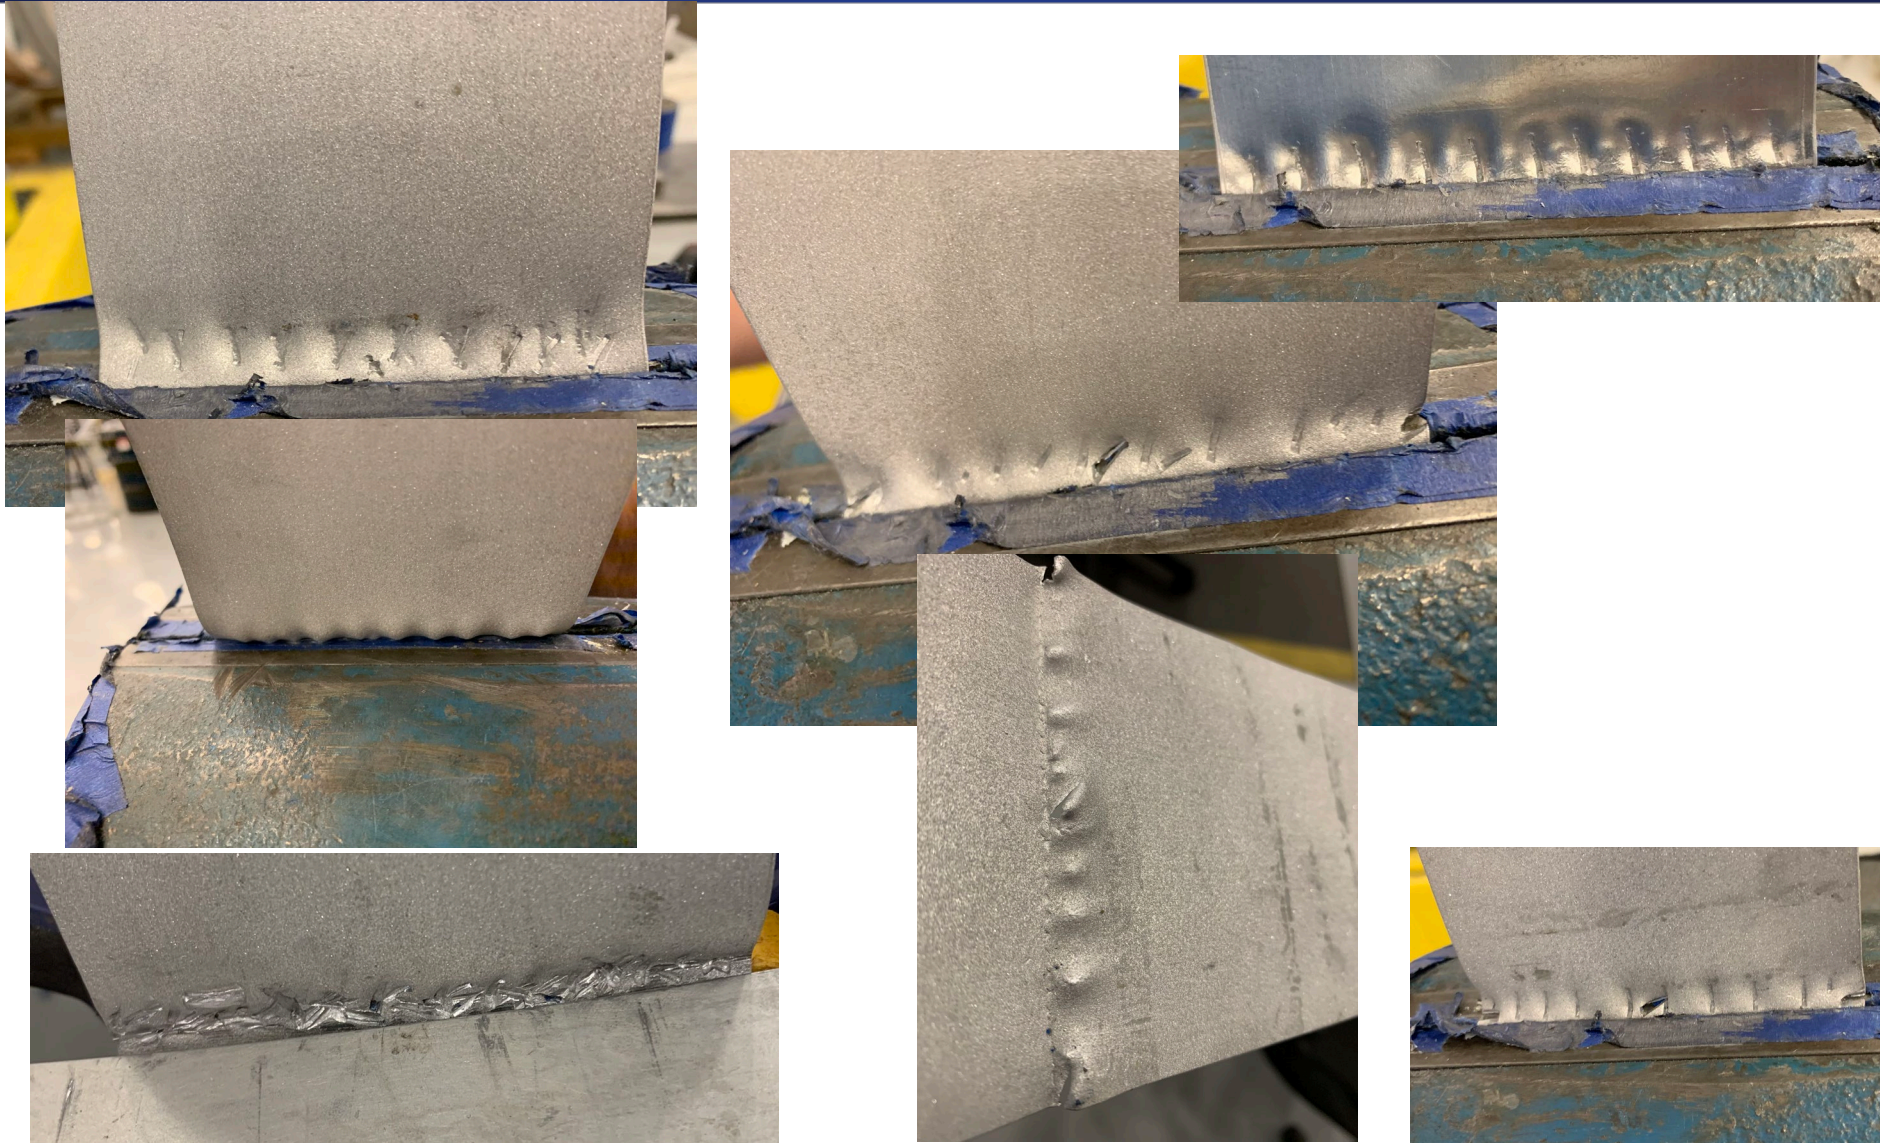
Simulated damage

- A strip of thermal bridge (worst case/grit blasted) was put into a vise and dented with a chisel covered by a cloth and a plastic head mallet... to best duplicate the dents seen on PS2 thermal bridges.
-
- The dented strip was then clamped to the ID of a DS mold and bent 90° over the edge of the mold by tapping it with a plastic head mallet until it was flat against the edge. A plastic block was also used afterward to flatten out any kinks or projections on the back of the thermal bridge.
- The thermal bridge was then raised back to vertical and lowered back to horizontal (a “full bend”) a number of times until a crack first appeared and finally until it broke entirely.

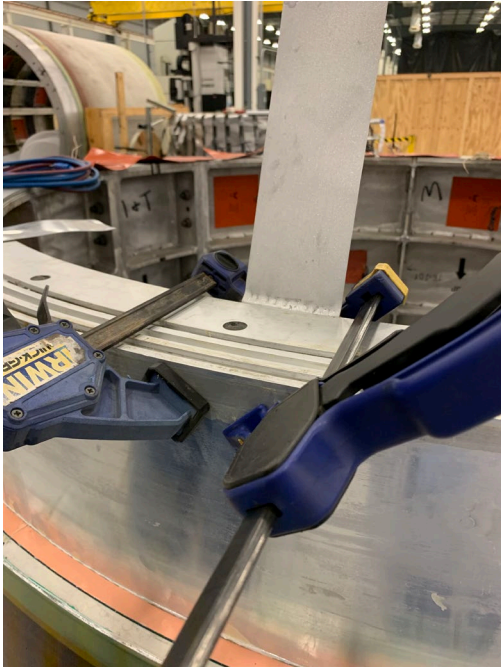
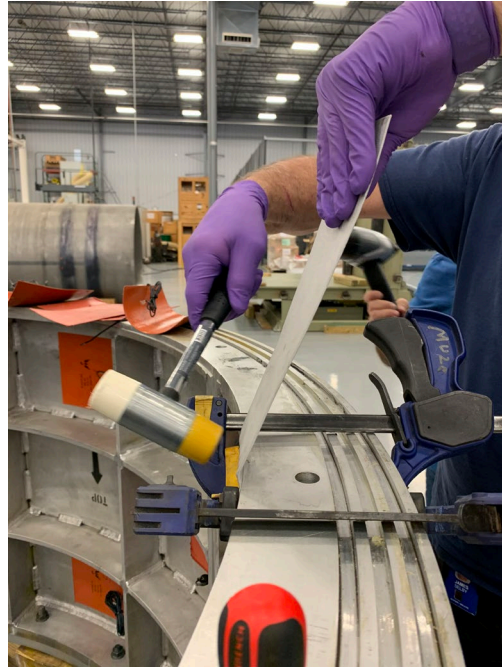
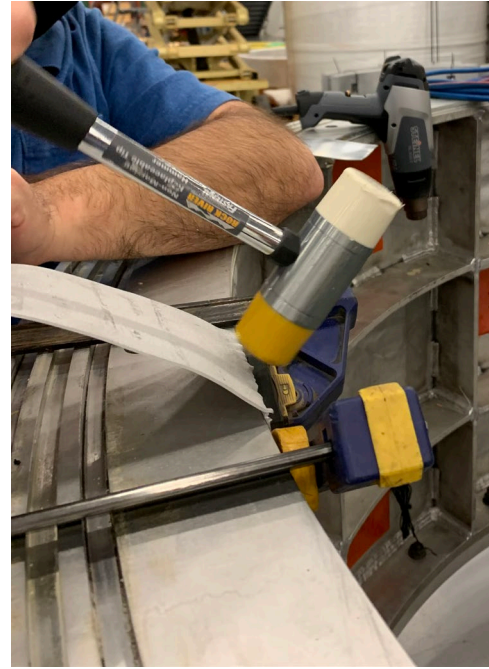
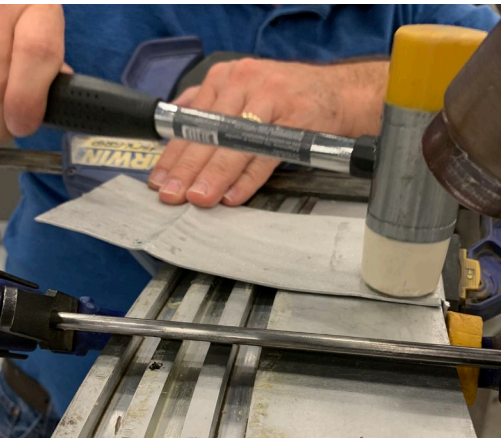
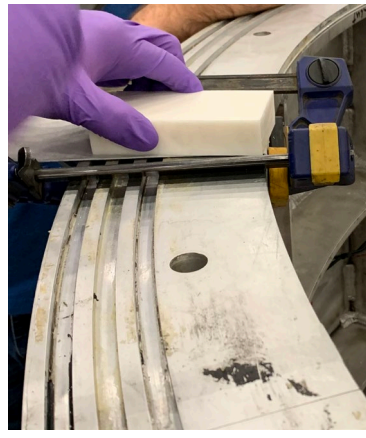
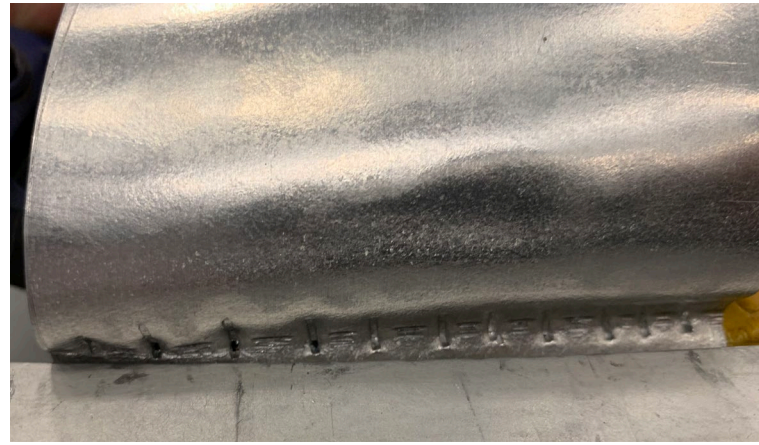
Bending Test

- **Most damaged thermal bridges began to crack after 7-8 “full bends” and to fully break around 13-17 full bends versus the control sample which lasted longer before breaking in two. One particularly damaged one had a crack at 4 bends, cracked through to the back at 7 bends, and broke fully at 10 bends.**
- **The work hardening from the flexing seemed to lead to final breakage of the parts more so than the dents (unless extreme). Any bending of the thermal bridges during assembly should be minimized as much as possible.**

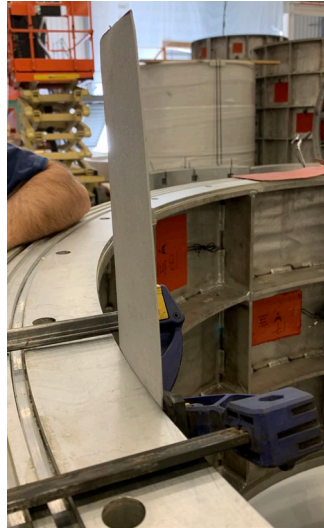
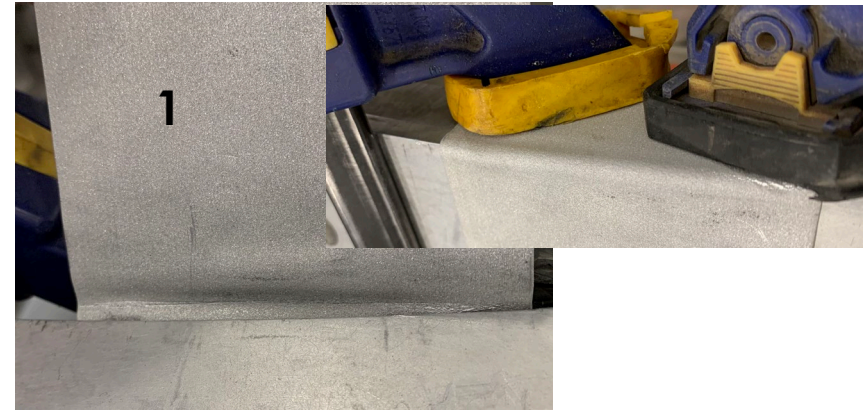
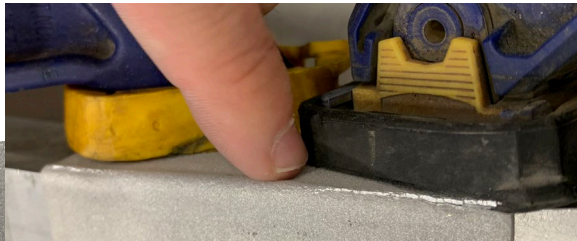
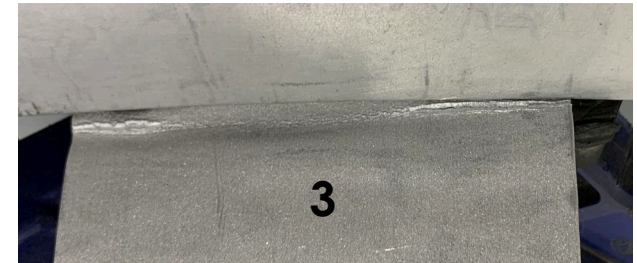
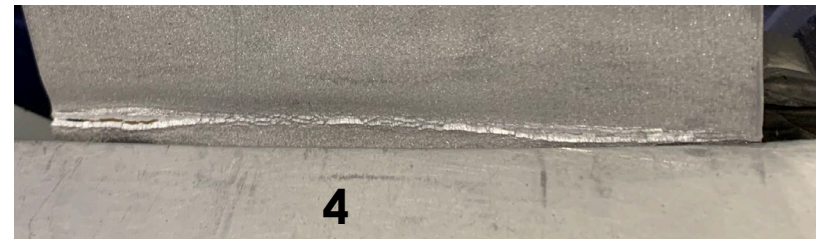
Control Sample Test

A grit blasted strip of thermal bridge with no dents or imperfections was tested as a control sample. Although the first small (1/2") stress crack was seen after 12 full bends, the strip did not completely break in two until bend#34

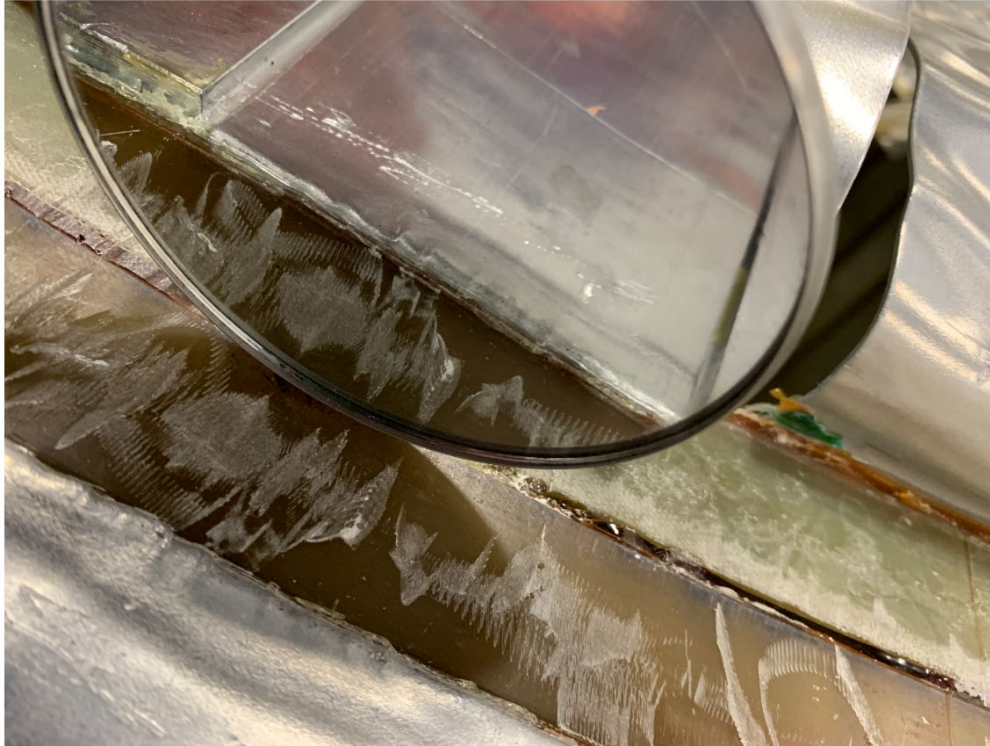
TB#5 after forming

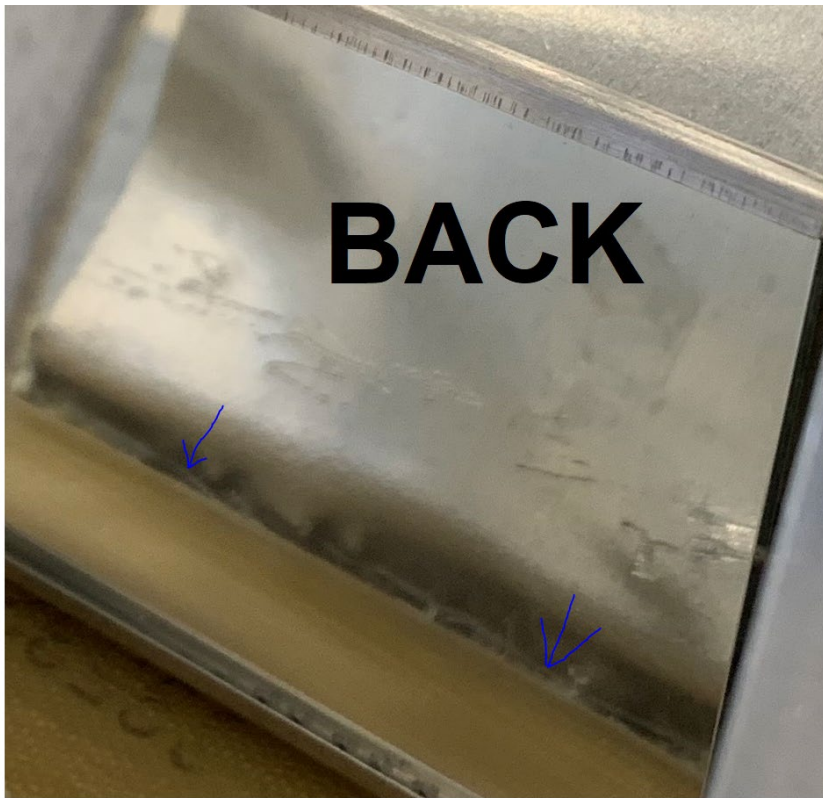
TB#5 before forming/ back side.
