(8) PART NAME: ZBOM		(9) PART/DWG NO.: 39532-D-3100			(10) REV: B
(11) CLASSIFICATION: (PRIORITY) Major	(12) LOCATION: EMS Tupelo	(13) HWCI NO. AND NAME: 39532-D-3105-2 - THERMAL BRIDGES, OD, PS2

(31) REQUIREMENTS: (DESCRIPTION) Thermal bridges to be continuous (PS2) 08/18/2020 16:16:04 PST SHARON DAVENPORT (DAVESH) Each thermal bridge to be a single continuous piece per Mu2e-doc-3647 (Reference Design of the Mu2e Production Solenoid.) 10/16/2020 08:25:18 PST (DAVESH) This text replaces the previous text: Each Outer diameter thermal bridge (39532-D-3105-2) must be produced as a single continuous piece of the length sufficient to make the connection with the cooling tubes per Mu2e-doc-3647 (Reference Design of the Mu2e Production Solenoid.)

(32) NONCONFORMING CONDITION: (TEXT) Item No: 0001 Found At: EMS Tupelo Defect Code: HDDM INS - Hardware Damaged Damaged outer thermal bridge(s) 10/16/2020 08:26:16 PST (DAVESH) During lead excavation on the PS2 Coil (39532-D-3122) per Mu2e Manufacturing Work Instruction 39532P00060, operation 320, a technician damaged the aluminum thermal bridges. Twenty-three outer thermal bridges were scratched and dented near their bases during removal of a

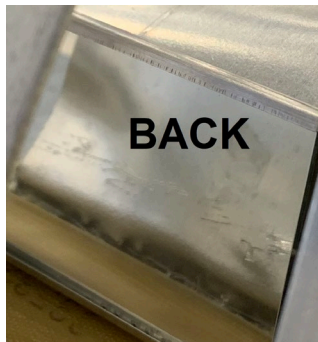
Pictures of Thermal Bridge 5

TB# 5 does have a small surface crack on the O.D. of the bend. It still feels "secure" not loose. Also, after reviewing the before pics it appears that this is not a new crack and was present before being formed into the slot.

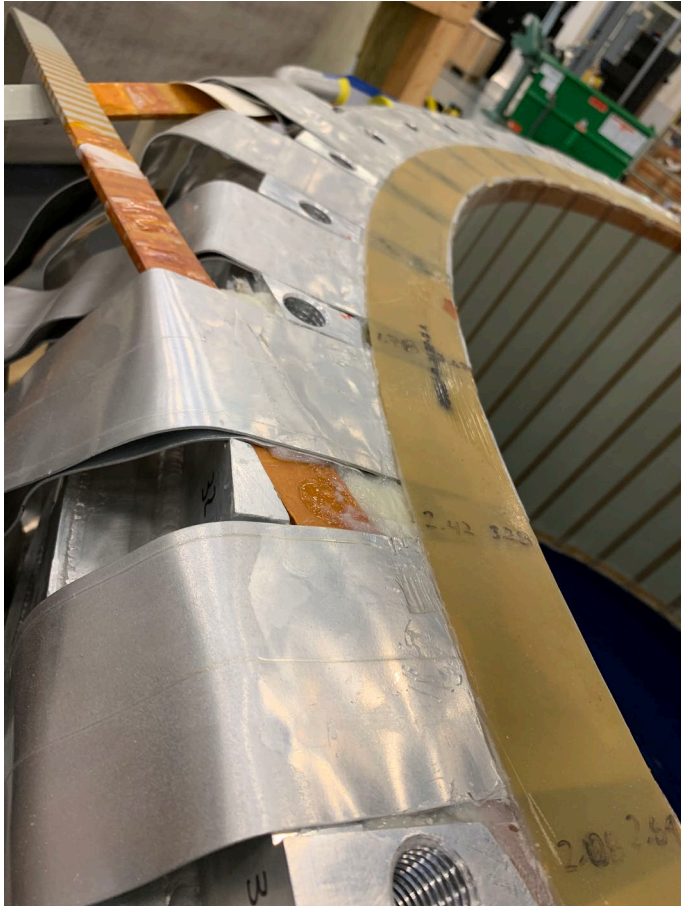
Bending Experiment

- **During Coil/Shell Assembly, the thermal bridges get bent 90° over the shell (sharp bend) and flattened to fit into their respective slots.**
- **This experiment was to see how a dented/damaged thermal bridge might be affected during the bending process**

- **Most damaged thermal bridges began to crack after 7-8 “full bends” and to fully break around 13-17 full bends versus the control sample which lasted longer before breaking in two. One particularly damaged one had a crack at 4 bends, cracked through to the back at 7 bends, and broke fully at 10 bends.**
- **The work hardening from the flexing seemed to lead to final breakage of the parts more so than the dents (unless extreme). Any bending of the thermal bridges during assembly should be minimized as much as possible.**

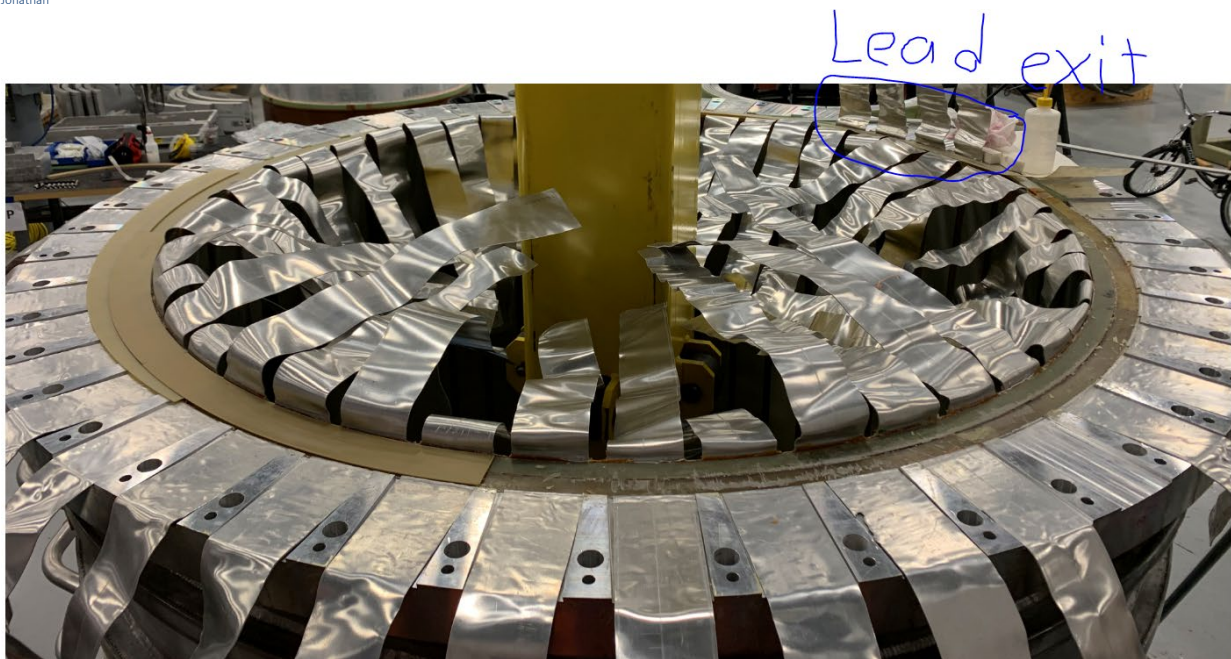
The tech training was performed this morning per the QN7071839, and the work on PS2 was resumed. So far all except four of the outer thermal bridges have been formed into the slots on the lead end. TB# 7 has been removed per the QN. No new cracks have been observed at this point. The last remaining four thermal bridges are in the lead exit area. They will not be formed into the slots until after the "wet layup" of the leads into their respective grooves. These 4 remaining thermal bridges are 15, 16, 17, & 18. FYI, #15 has the 2nd worst initial damage.
